Bainbridge Township, in partnership with Chagrin River Watershed Partners, was awarded a \$333,250 Ohio EPA Section 319(h) grant in 2020 along with \$50,000 in local match from the Township to stabilize 750 linear feet of Smith Creek, a designated coldwater stream and tributary of the State Scenic Aurora Branch of the Chagrin River and create 3 acres of wetland floodplain. The project lies at Centerville Mills Park, a former YMCA youth camp now owned and managed as a public park by Bainbridge Township.

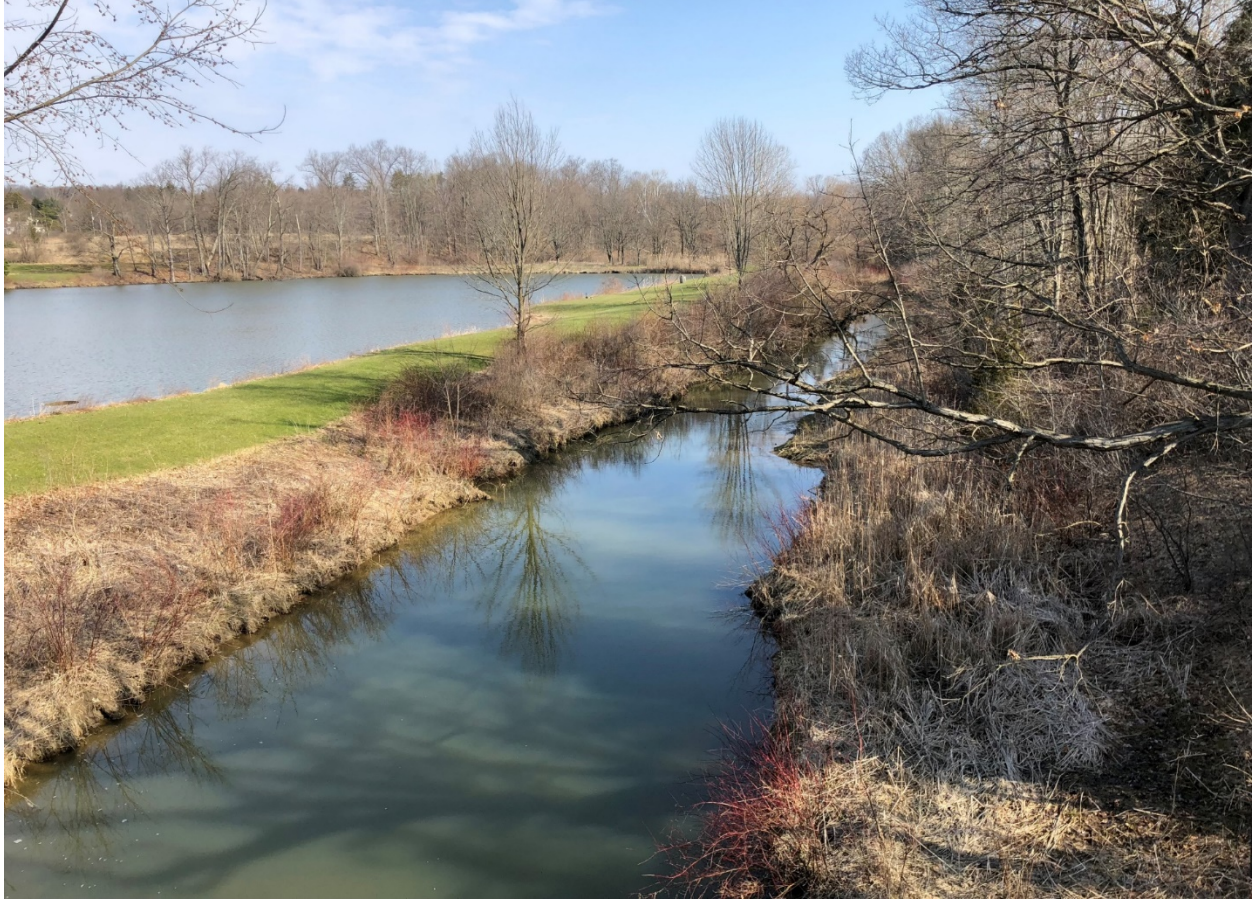
Figure 1 Smith Creek Channelized throughout Centerville Mills Park facing north from Crackel Road (2018)

Prior to restoration, Smith Creek was channelized throughout Centerville Mills Park, had limited floodplain connection, and was severely eroding the adjacent earthen dam of Lake Paterek which risked breaching. This erosion led to serious sedimentation issues downstream and threatened Smith Creek's cold water habitat status. Floodplains are important for dissipating the erosive energy of high flow floodwaters and filtering out pollutants from water. Streambank erosion jeopardizes nearby infrastructure and contributes excessive sediment and pollutants to downstream areas, leading to unhealthy habitat conditions for aquatic life.

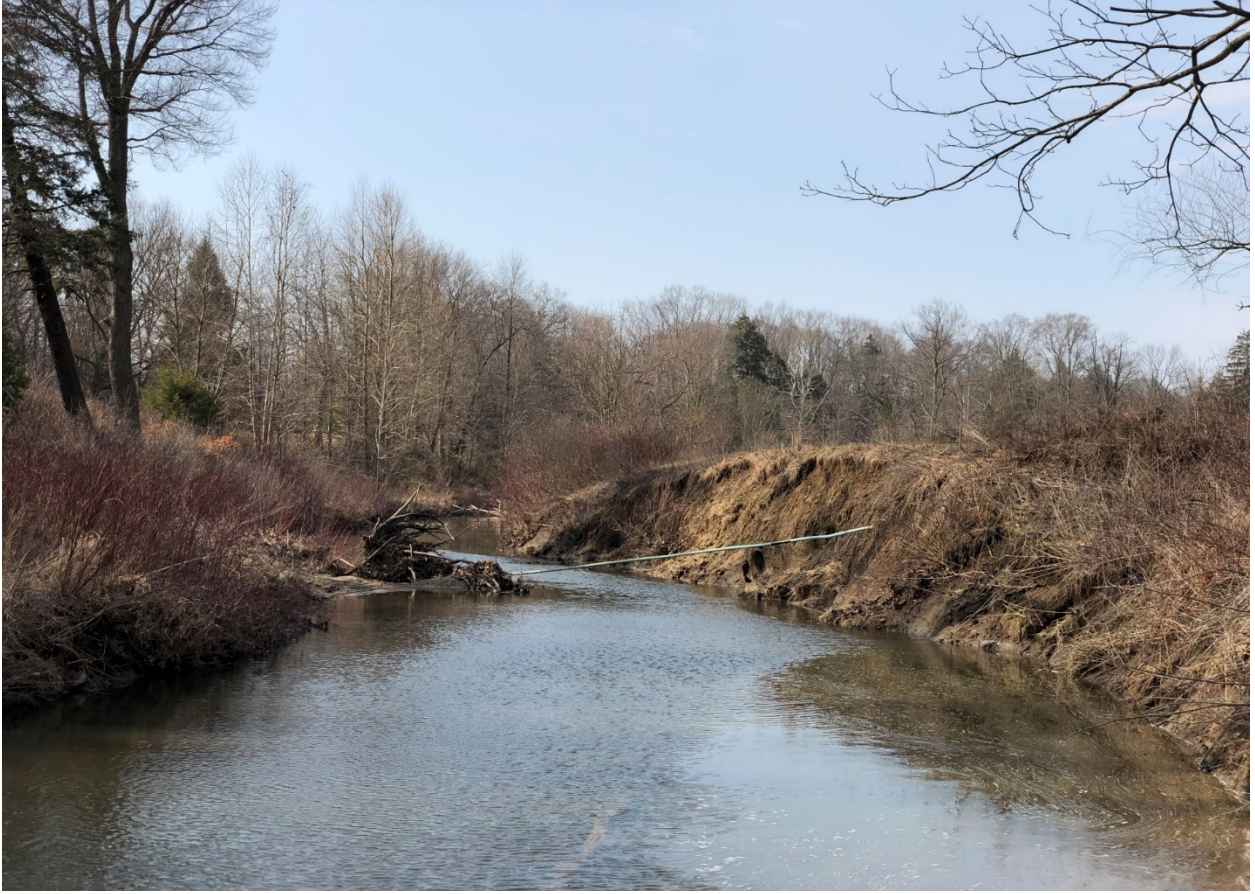
Figure 2 Smith Creek experiencing significant erosion throughout Centerville Mills (2018)
